CLEANING CONTAMINATED ELECTRODES

TITLE			
ROUTINE CLEANING PROCEDURE			
SIZE	PROJECT / SO#	DRAWING NO.	REV
A	CLEANING	2003121	A
			SHEET 1 OF 3

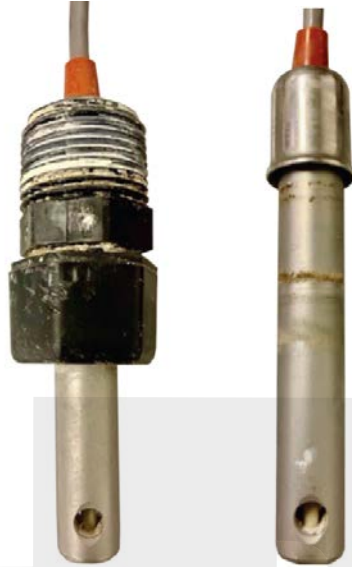
The sensor passed visual inspection. With no signs of corrosion or damage to the electrodes. The outer and inner electrodes were contaminated with a foreign substance. After it passed visual inspection the sensor was wet tested "as is" to see where the readings were coming in at. The sensors conductivity readings were off almost 20% from the nominal cell constant value. The lower than expected readings indicate contaminated, aka "dirty" electrodes.

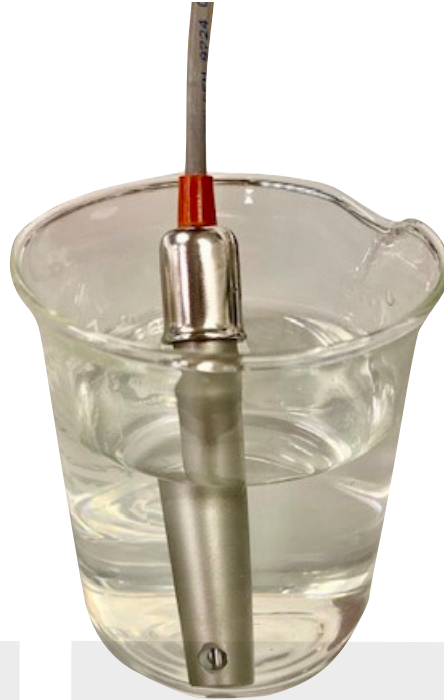
Once the cleaning procedure was completed the sensor was rinsed with fresh distilled water and wet tested again to see if the readings improved. This time the sensor tested as expected and came back with almost perfect results. Testing within 1% of the nominal cell constant value. Implementing a routine cleaning procedure following these steps could extend the service life significantly.

Next, the sensor was soaked in a solution of hot water and a small amount of detergent (Alconox). After the hot soak, the body and inner electrode were wiped down again with a paper towel, pipe cleaner and q-tip.
